St. Forchern's Restoration Works

Protected Structure ref: CW 449 NIAI 10302303

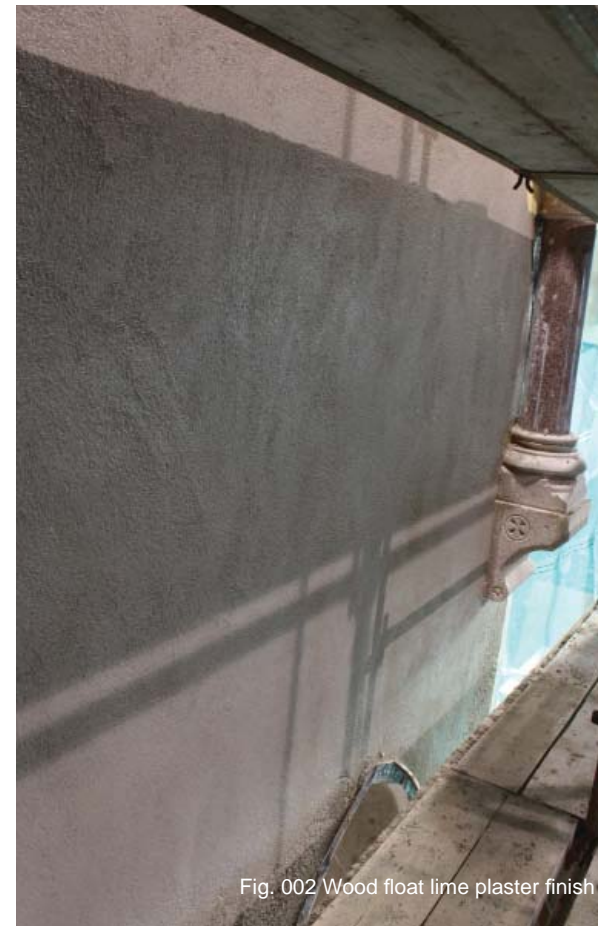
Fig. 002 Wood float lime plaster finish

Work is progressing well at St Forcherns Church, we hope to complet all works next week with the scaffolding being taken down also. a number of coats of lime plaster has been applied to bring back up to the original thickness. the find edge detail around the side window and vestry door is complete and the final coat is on the two side walls. the rear wall is the remaining elemnt of work.

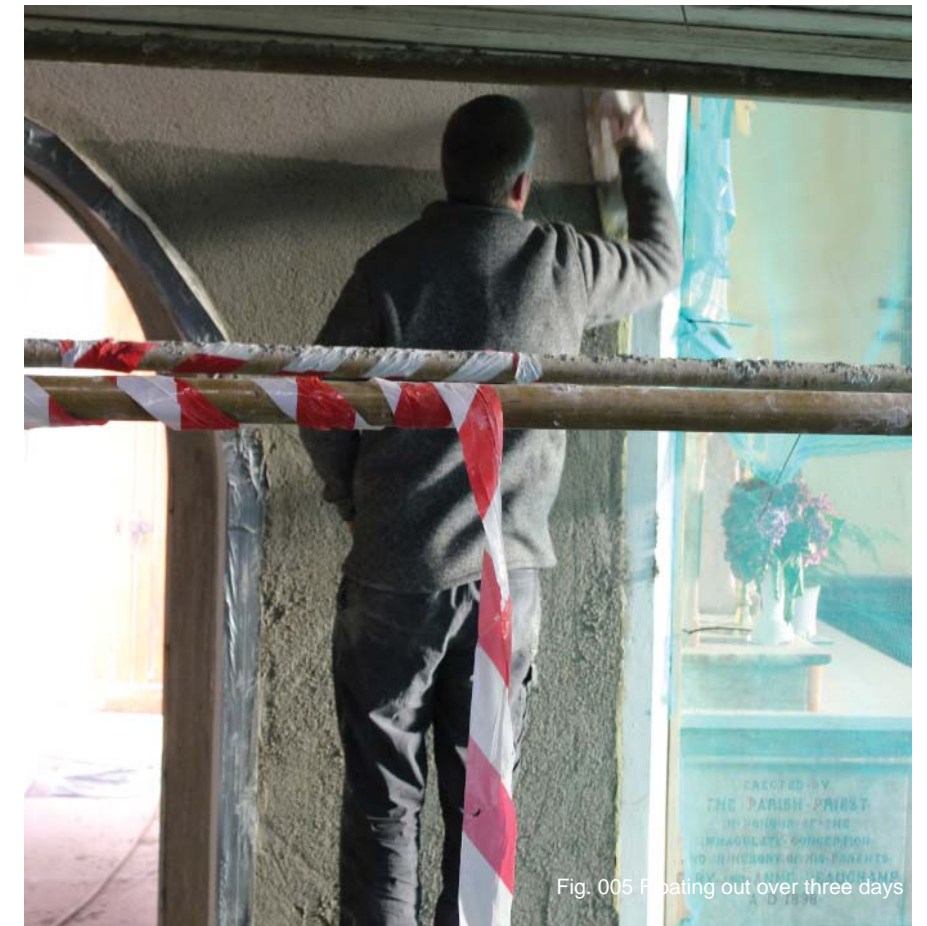
Fig. 005 Floating out over three days

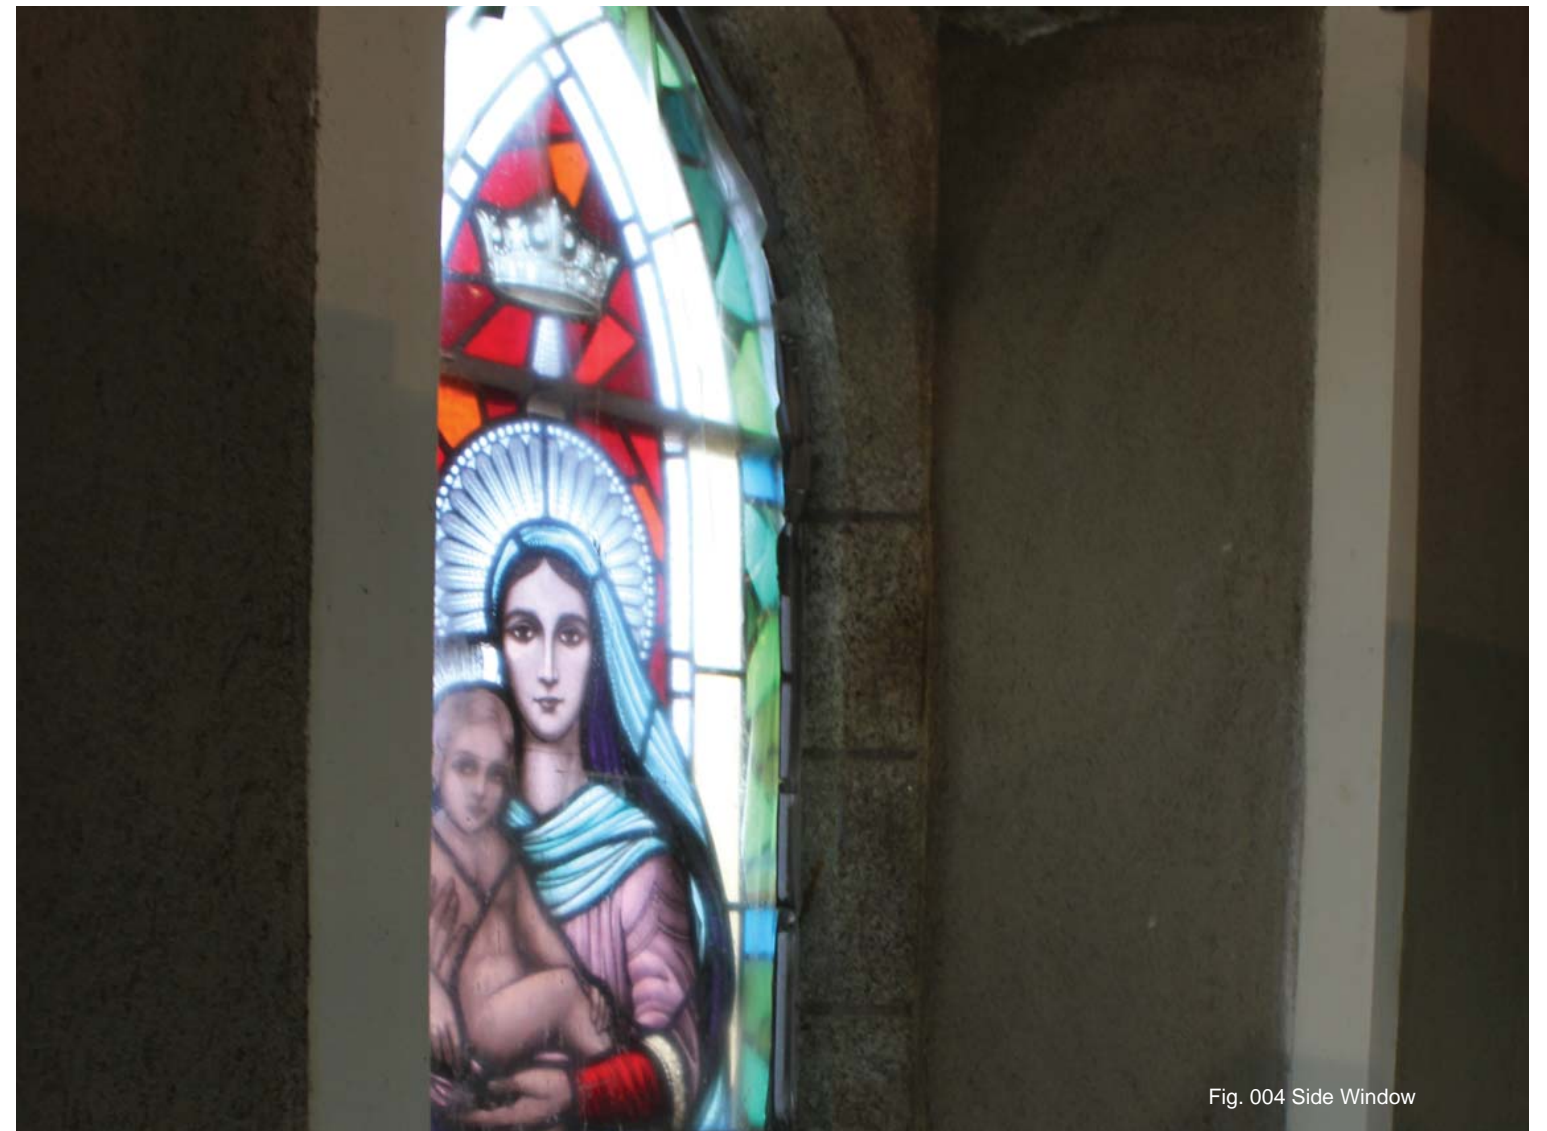
Fig. 004 Side Window
